1969
TRIUMPH
TR6

1969 TR6 VIN: CC29605L Block Number: CC60083E

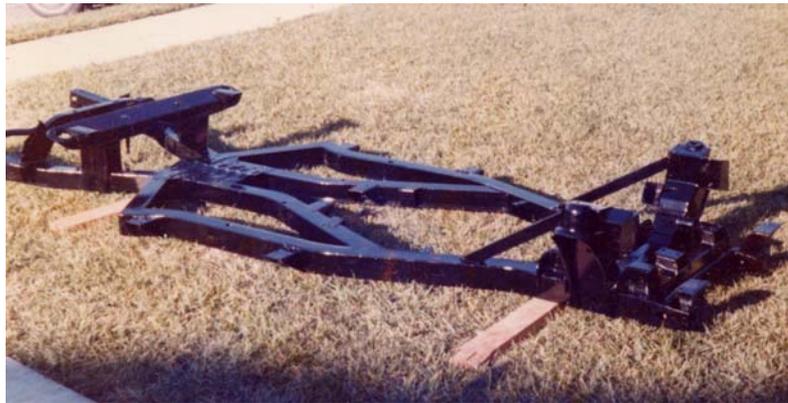
- Replaced frame with excellent frame recovered from salvaged car. All aspects of the frame in perfect shape, including rear differential mounts. Reason for replacing the frame; rusted out frame members where the rear trailing arms attached. Sandblasted. Outside painted with black polyurethane. Interior tubes flooded with rustoleum primer. Current condition the same with some very limited surface rust where paint was scraped off.

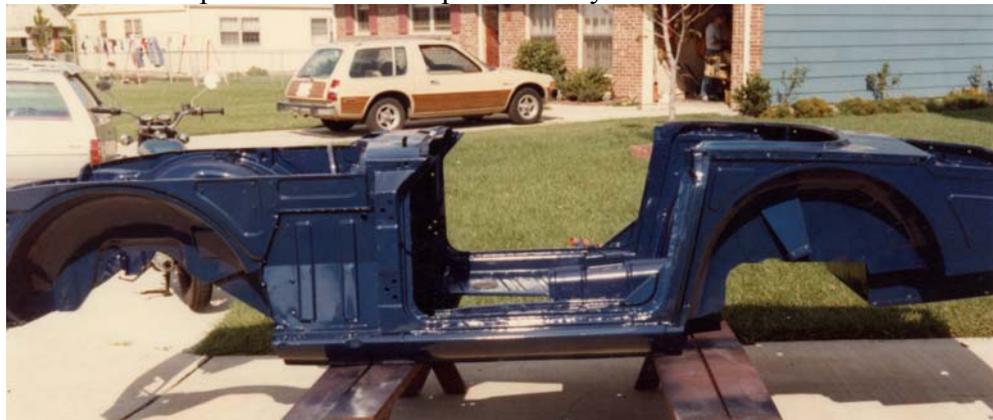
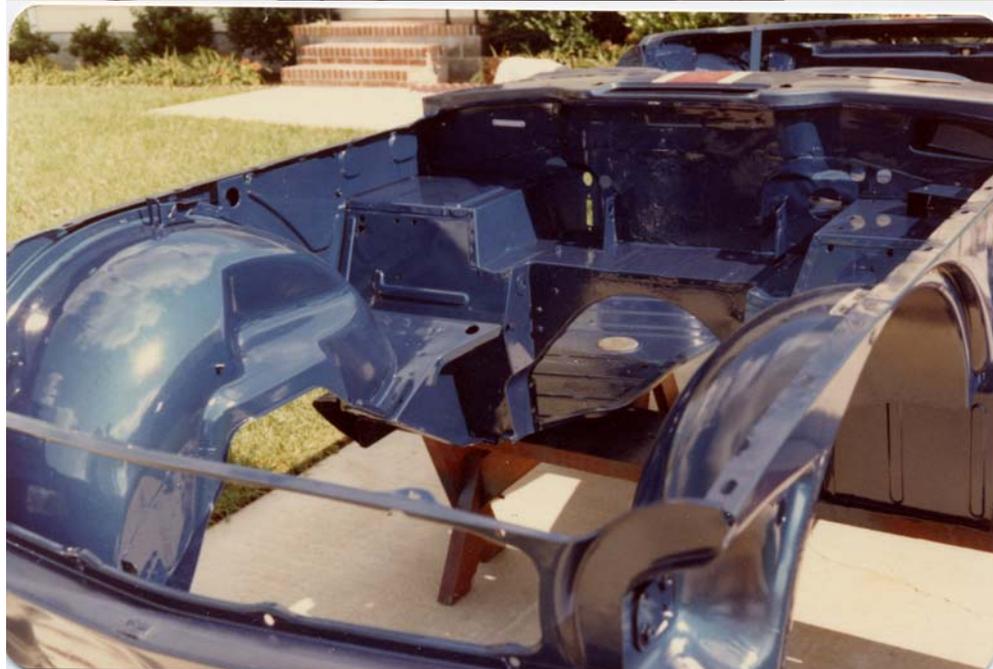
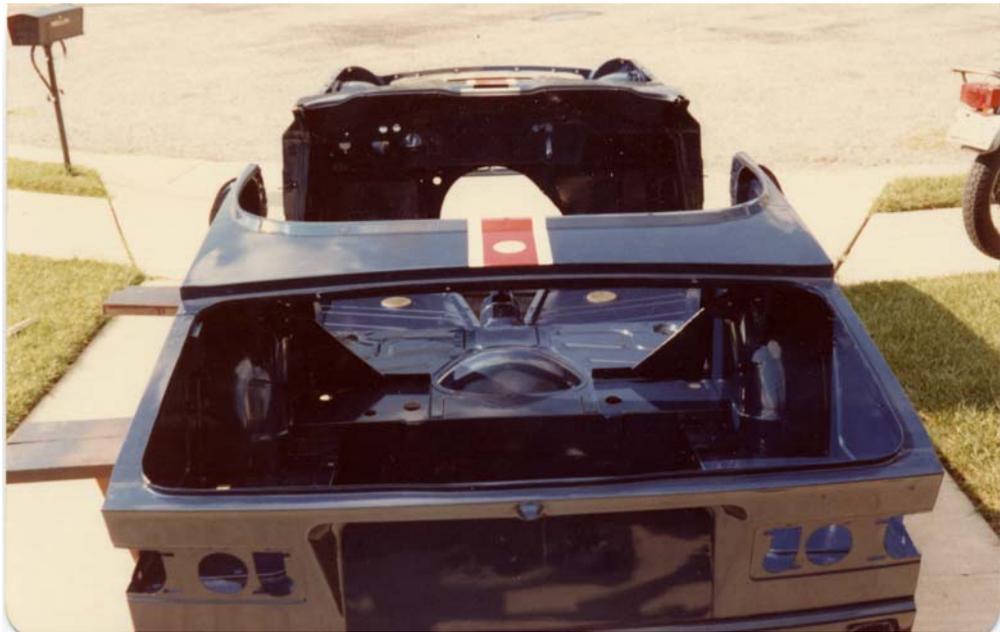
- Main body shell was dunked in Newport News shipyard vats to remove all paint and rust. Old, rusty rocker panels cut and ground off, new rocker panels spot welded on. Interior of rocker panels flooded with rustoleum primer. Any holes caused by rust-thru were repaired with fiberglass, mostly in the battery compartment. Any area not seen by the public while being driven painted with enamel with polyurethane hardner. All visible areas painted with lacquer. Replaced cardboard based transmission tunnel with aftermarket fiberglass transmission tunnel. Current condition: very limited surface rust where paint has been scraped and 15 years of dust and dirt.

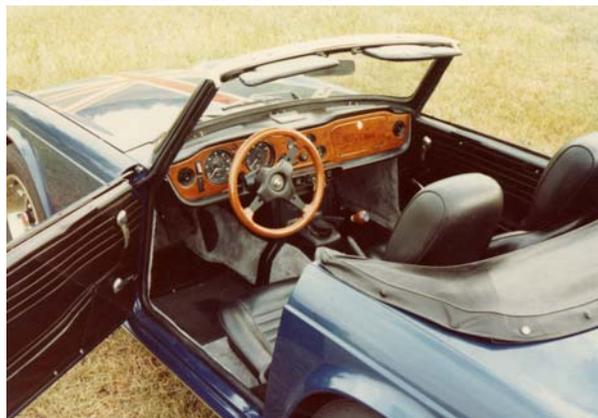
- Seats and Interior: Seats are surprisingly in decent shape for as old as they are and how long they have been in storage: useable. Have a padded dash that has never been installed. Padded transmission to dash structure in better than fair condition. Padded dash pieces under the dash left and right useable, probably would want to replace. Wood dash was refinished and coated with a clear resin. Glovebox door probably needs some more work to match the dash.

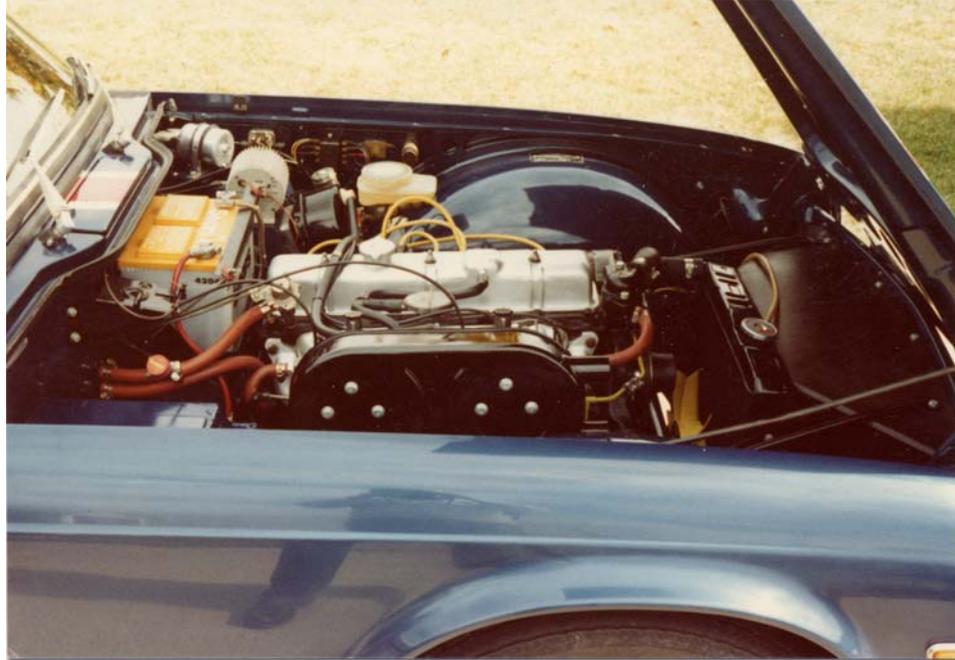
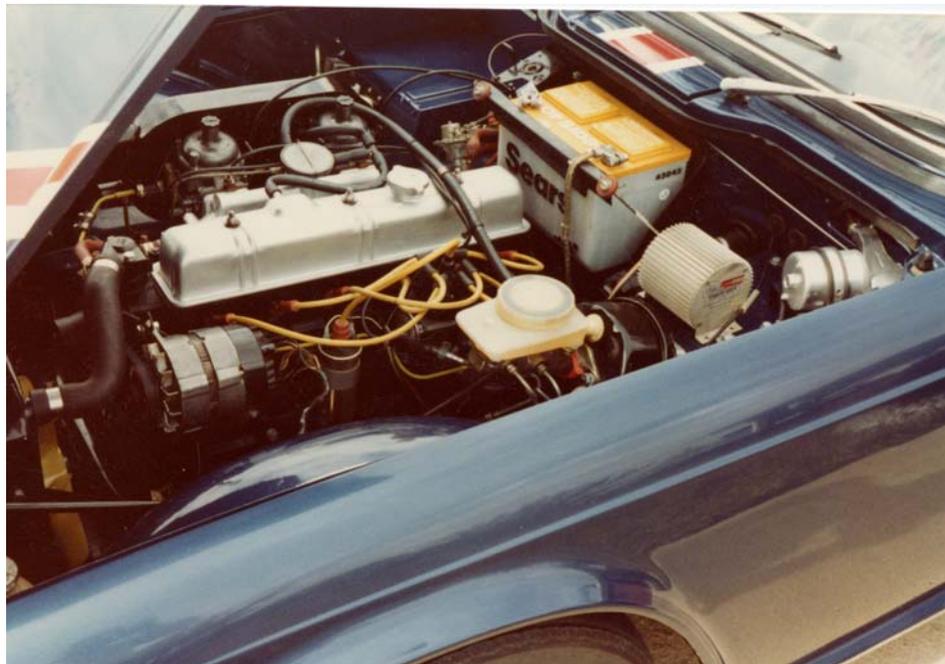
- Engine completely rebuilt to factory specifications. Drove 36,000 miles getting 26 miles to the gallon and always passed emission standards for the day. Total current condition is unknown but not working. When put in storage in 1983, the cylinders were filled with engine oil for preservation. However, my dad not realizing the engine was packed with oil, tried to start the engine. Engine has not been touch since.

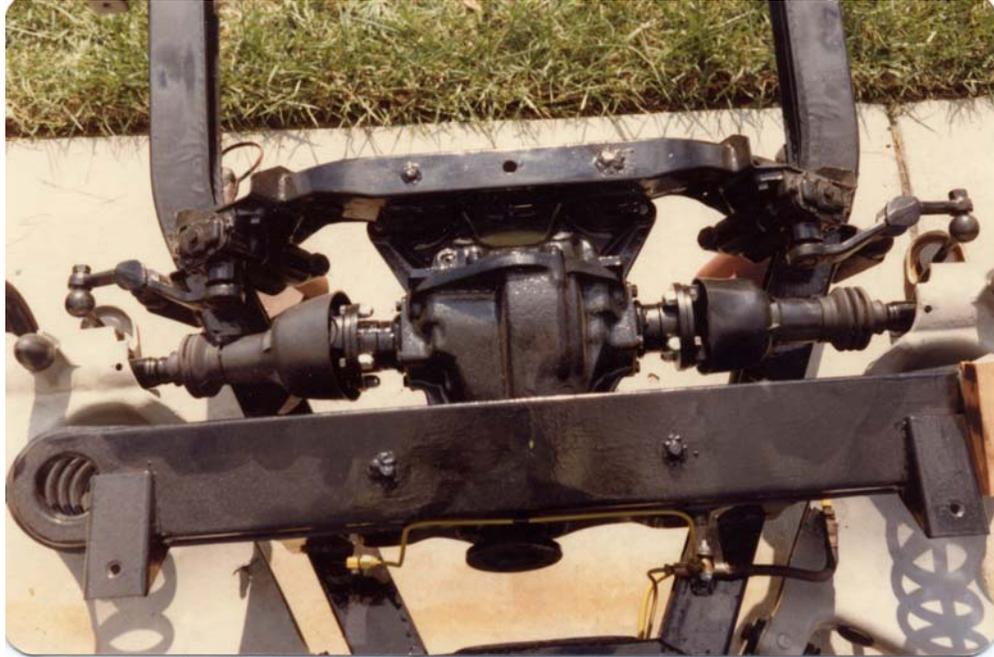
- Transmission: totally rebuilt to factory specifications. Replaced most of the synchro cups and re-shimmed to factory specifications. As I recall, I only replaced one major gear, think it was third. Current Condition: The same except for 20 years of storage and 36K miles.

- Differential: Rebuilt to factory specifications, which included replacing the crown wheel pinion set. Worked fine and made no noise at any speed (90 is the fastest I ever took it). Current condition: same except for 20 years storage.

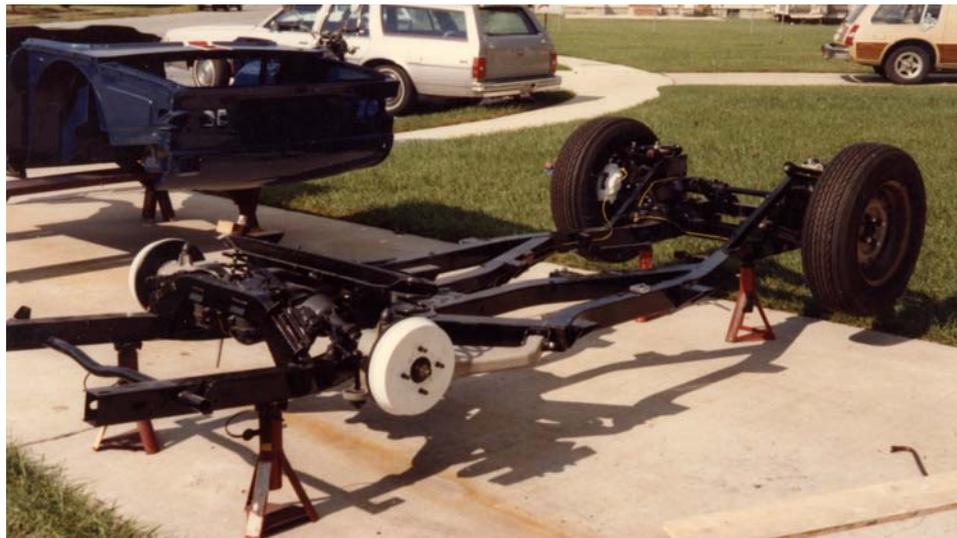
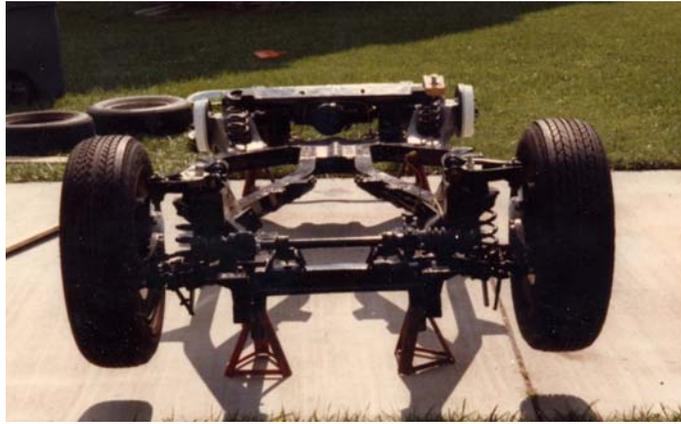
- Steering: rebuilt the steering box and replace all mounting rubber. Condition today: Same except needs a new steering column coupler, which I believe I bought in England in '87 and haven't installed (I need to find it).
- Suspension: Rebuilt with all new rubber and nylon bushes. Replace one of the front bottom trunnion assemblies. Tires are unusable and deflated.
